Manhole Inspection Summary

Manhole # S29K__005MH

Insp Date: **10/27/08 11:03 AM**

Location Address: **829 Clifford St**

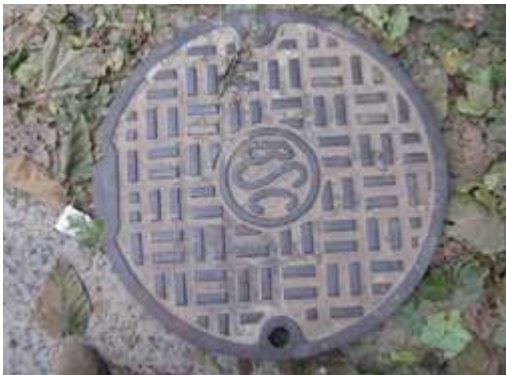
mh cover

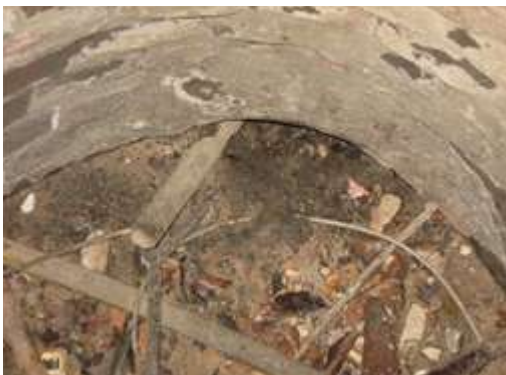
Defect 5

Condition: ☐ Sound ☐ Cracked ☐ Root Intrusion ☐ Deteriorated ☐ Leaks ☒ **Debris**

debris in channel and pipe

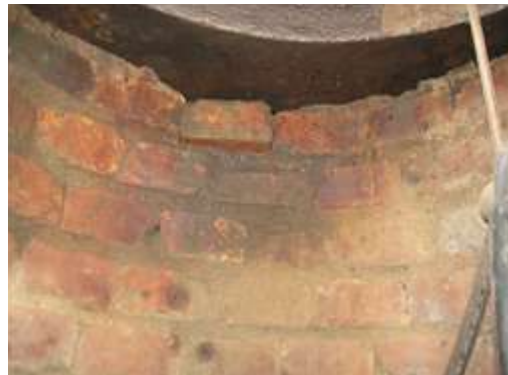
Defect 4

Condition: ☐ Sound ☐ Cracked ☐ Root Intrusion ☒ **Loose Brick** ☐ Deteriorated

Infiltration: ☐ None ☐ Joint ☐ Cracks ☐ Mortar ☐ Roots ☒ **Wall**

infiltration frame/chimney joint & loose bricks

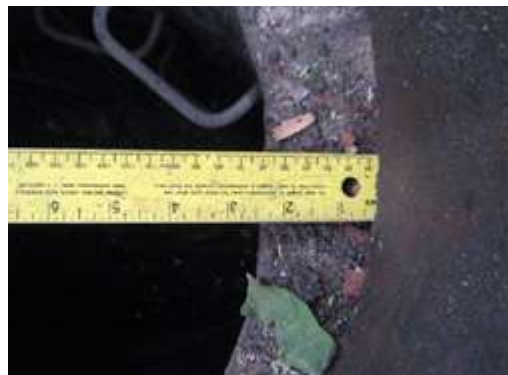
Defect 3

Offset: **2.5** (in.)

offset 2.5"

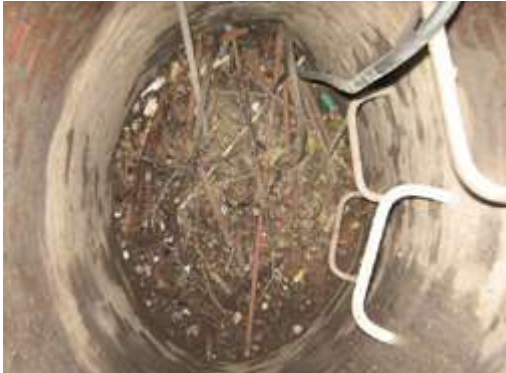
Defect 2

heavy sediment and debris in bench and channel, infiltration along corbel and barrel walls

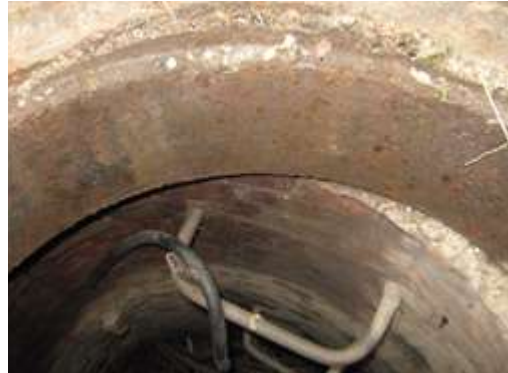
Defect 1

frame infiltration

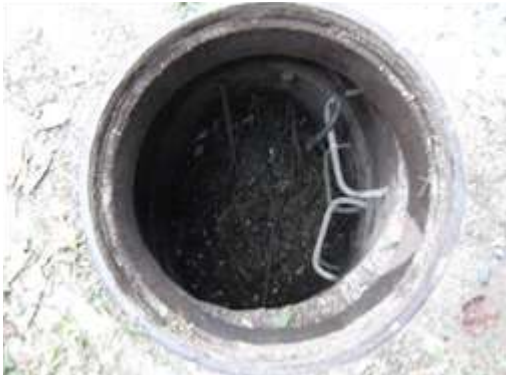
Condition: ☐ Sound ☐ Cracked ☒ **Leaks**

frame leaks
